**KIRKBURTON PARISH COUNCIL**  
**Burton Village Hall**  
**Northfield Lane**  
**Highburton Huddersfield HD8 0QT**

**Repair to Boundary Wall at Shelley Village Hall**

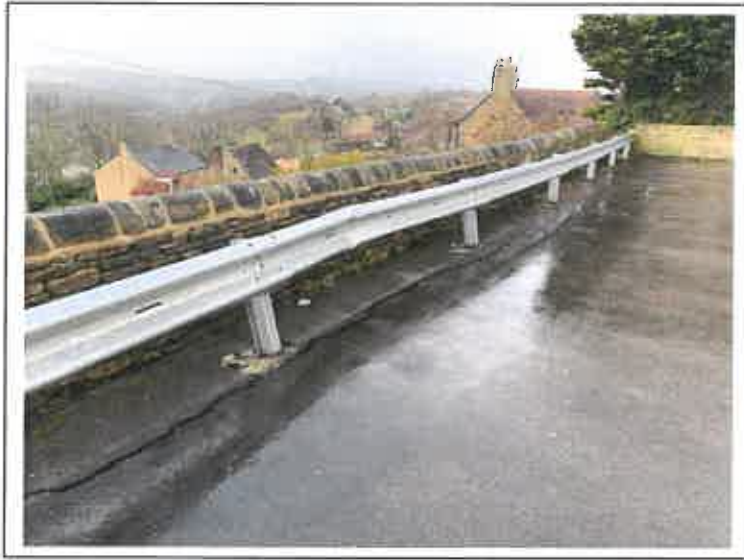
General view of impact damaged area.

- Damaged pointing to the coping stones to be raked out and replaced.
- Replacement of the damaged rail.
- Damaged posts to be removed and new posts to be installed.

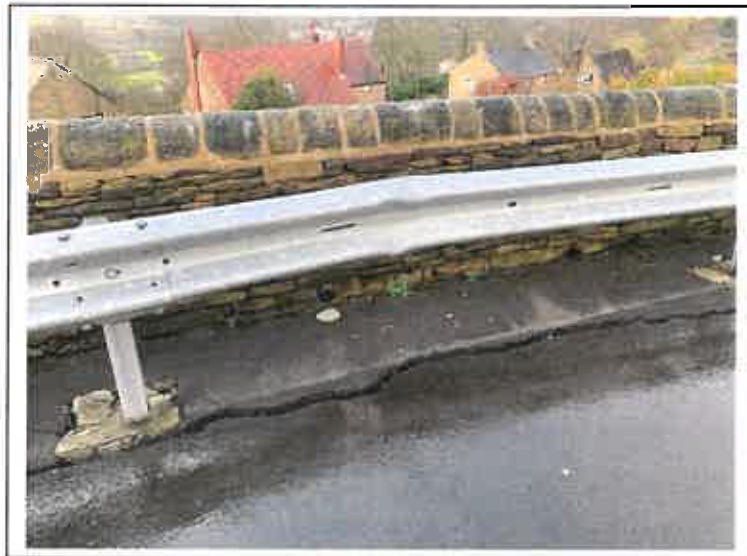
Point of impact to rail.

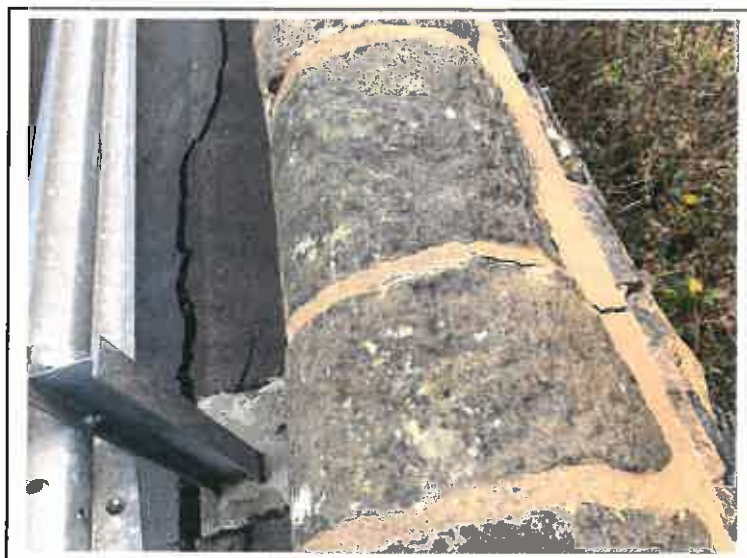
Example of cracked pointing to coping stones.

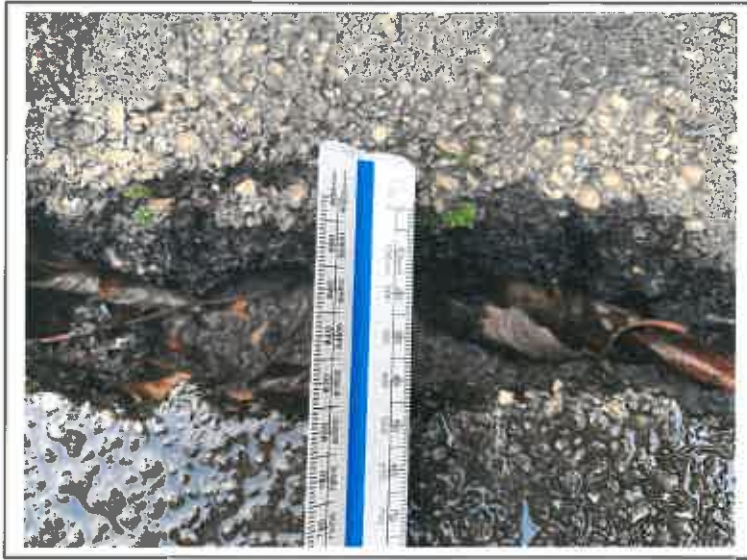
Cracking to Tarmacadam surface.

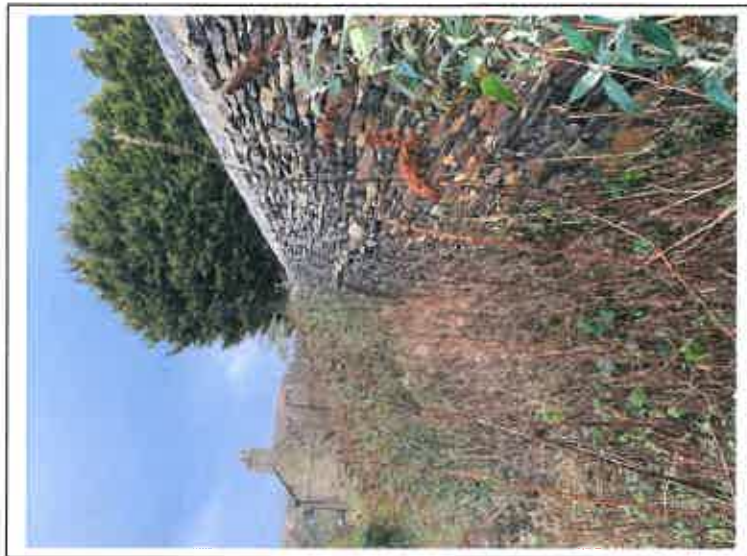
'Bellying' to retaining wall.
